SERVICE INFORMATION

Vol. 1 No. 1

LAND-ROVER PETROL AND DIESEL MODELS

The Rover Company Limited, Solihull,
Warwickshire, England

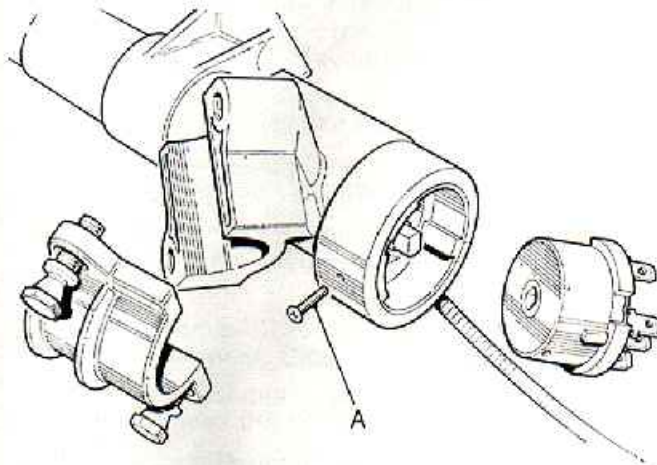
Fig. 1 Steering column lock (petrol type illustrated)

A number of complete steering column lock assemblies have been returned under warranty when only the ignition and lock switch on petrol models (heater and lock switch on diesel models) was known to be faulty. It is emphasised that the switch unit can be replaced separately from the main assembly. However, to gain access to the switch it will be necessary to remove the steering column lock first.

1. Disconnect the battery earth lead.
2. Disconnect the cold start control or engine stop control as applicable, in the engine compartment.
3. Remove the fixings and withdraw the steering column upper shroud.
4. Remove the fixings and move aside the lower shroud.
5. Centre punch and drill a hole in each sheared bolt to accept an extractor.
6. Remove the sheared bolts, using a suitable 'Easy-out' extractor.
7. Withdraw the steering column lock and retainer saddle.
8. Disconnect the electrical leads at the switch.
9. On petrol models, remove the single 'Posidrive' screw which retains the ignition and lock switch, as illustrated. The larger heater and lock switch used on diesel models is held by two 'Posidrive' screws. Both types of switch unit are provided with a keyway to ensure correct location on replacement.

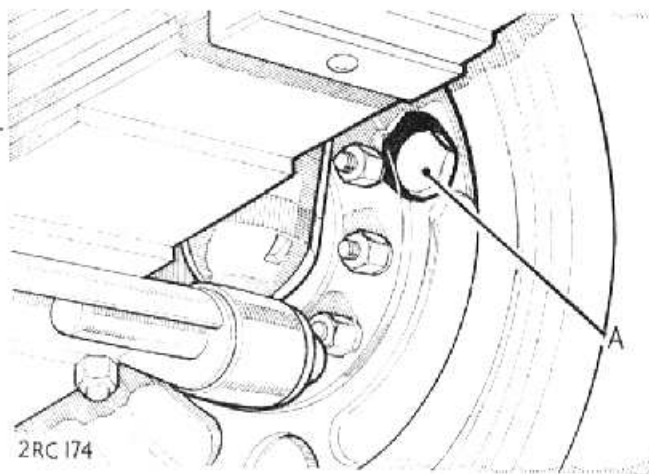
Fig. 1 Wheel brake adjustment

REMARKS: If low brake pedal is a problem in Service it has been found that an improvement can invariably be made by carrying out the simple adjustment procedure to the **rear brakes** as detailed below.

1. Raise the rear of the vehicle and place on stands.
2. Ensure the rear wheels turn freely.
3. With the foot brake firmly applied adjust **one** snail cam to its maximum position.
4. With the foot brake released, undo the cam one or two notches until the wheel just turns freely.
5. Repeat operations 3 and 4 on the remaining rear brake shoe snail adjuster.
6. Check the brakes for correct operation.
7. Lower the vehicle to the ground.

This operation centralizes the brake shoes to the drum without putting any excessive strain on the snail adjusters which could result in damage.

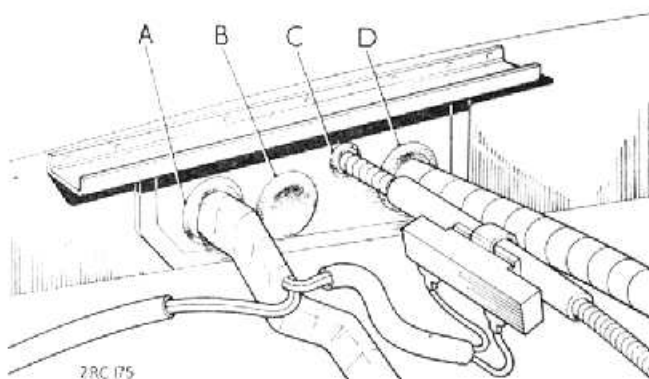
Fig. 2 Correct location of speedometer cable RH Stg. models

Some early Series III vehicles have the speedometer cable routed through the grommet hole which is normally blanked off. This incorrect assembly forces the cable through a sharp angle and can promote early speedometer inner cable failure.

Service Personnel should familiarise themselves with the correct layout as illustrated and give particular attention to this point when early Series III Land Rovers are inspected.

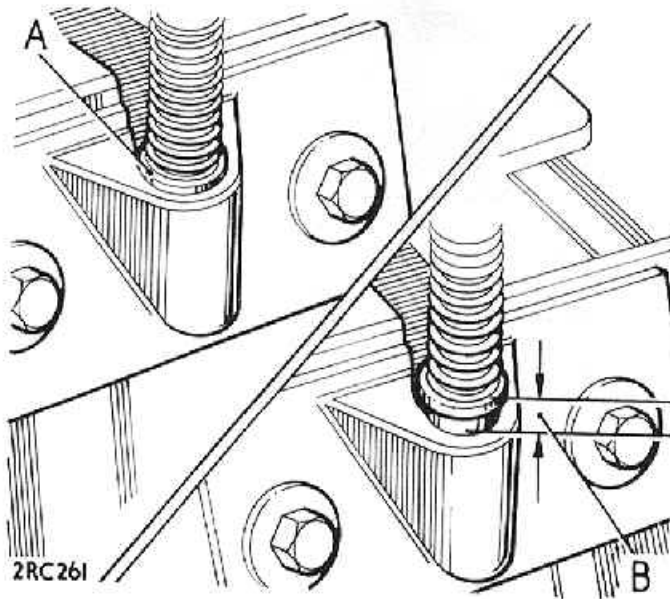
Fig. 1 Location of bush for 4-wheel drive selector rod

REMARKS: Recent investigations into a complaint of inability to select four wheel drive high range revealed that the selector rod return spring became coil bound. This was caused because the external diameter of the bush was too large, which prevented the bush seating properly in the cover plate.

The bush should fit almost flush with the cover plate, but with incorrect tolerances it may be approximately 50 mm ($\frac{1}{2}$ in.) too high.

A—Bush correctly located in cover plate

B—Bush too high in cover plate which will cause the spring to become coil bound

Should this condition be encountered we recommend that the cover plate be removed and the hole enlarged to accommodate the bush.

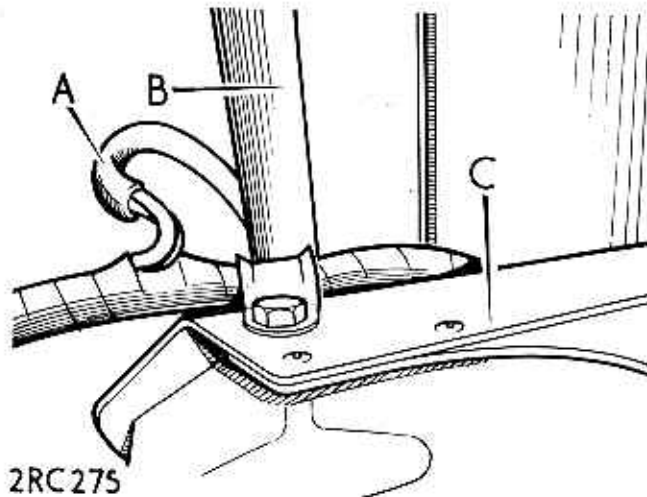
Fig. 1 Correct location of solenoid feed wire

- REMARKS:** It has been brought to our attention that in certain instances a 'foul' condition may be present between the air cleaner, main harness assembly and the right hand side wing valance.
- Service personnel are requested to examine all earlier vehicles, during routine maintenance checks and, if required, peel back the non-adhesive harness binding tape, thus allowing the solenoid feed wire to be re-routed away from the obstruction.
- Should the solenoid feed wire be badly chafed, it should be replaced with the modified main harness assembly.
- All Service stock of the main harness assemblies are to the latest specification.

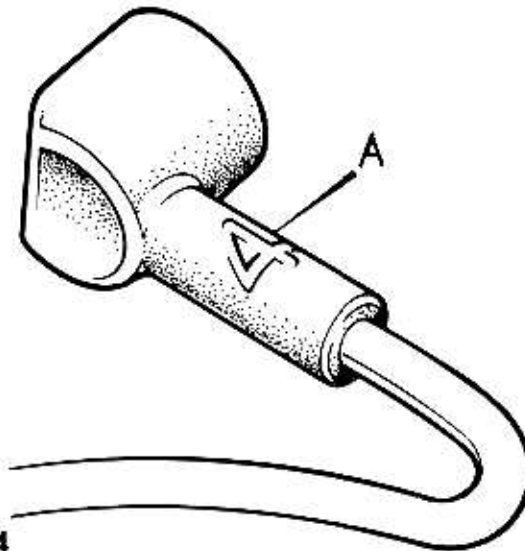
**2RC274****Fig. 2 Identification of ignition lead**

- REMARKS:** Several cases of engine misfire, and poor starting under wet or damp conditions have been reported and investigation has shown this to be caused by poor moulding of the right angled coil boot on the coil to distributor high tension ignition lead.
- If this condition is detected or brought to your attention by an owner, on vehicles sold during the last 12 months, then the coil to ignition lead must be changed for the modified type, which has a moulding number stamped on the right angled coil boot. The earlier type has no moulding number.
- Distributors and Dealers are requested to keep a careful watch for this condition during routine servicing.
- In order that the cost of this action may be correlated, it is essential that all Warranty Claims contain code A326 in place of the normal Warranty Complaint Code.
- The time allocated for this operation is 0.5 hours.

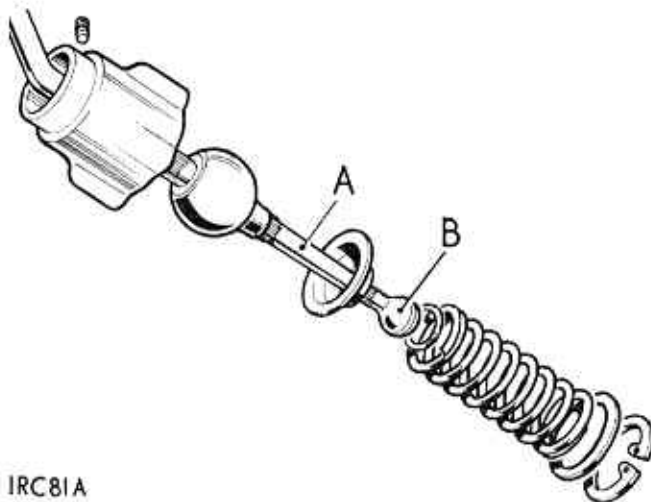
Fig. 1 Gear lever assembly

REMARKS: Over a period of time there have been instances of failure of the Polyurethane material used for the ball end attached to the gear lever on Series IIA vehicles.

Any future recurrence of this problem should be satisfactorily remedied by fitting a replacement gear lever.

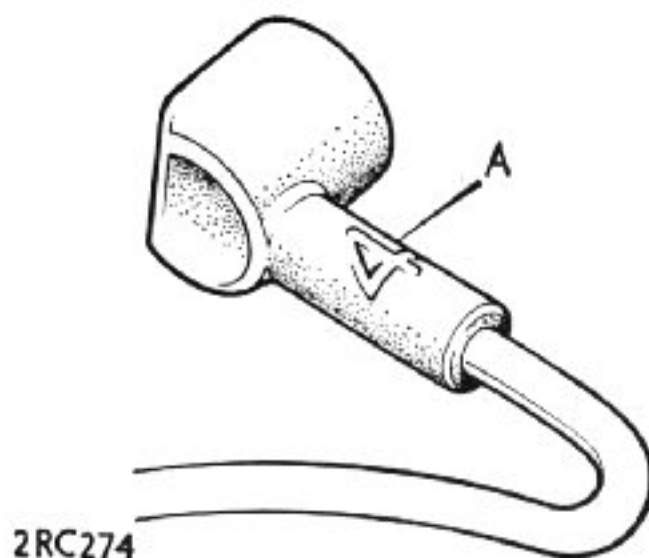
Fig. 1 Identification of moulded 'boot' on coil to distributor HT lead
A—Moulding number

REMARKS: We would draw your attention to the comments made in Service Information Vol. 1 No. 6 Item 19, regarding engine misfire and indifferent starting under wet or damp conditions owing to poor moulding of the right-angled boots on a batch of H.T. leads. According to our records only a small response has been made to this information. It is, however, anticipated that the forthcoming winter will aggravate the problem and you are therefore requested to pay particular attention to this point at routine service periods or if a particular criticism is made by an owner. It is essential that any warranty claims for rectification arising from this action contain Code A326 in place of the normal warranty complaint code in order that costs may be correlated. Warranty claims for rectification will not be accepted after 5th February 1973.

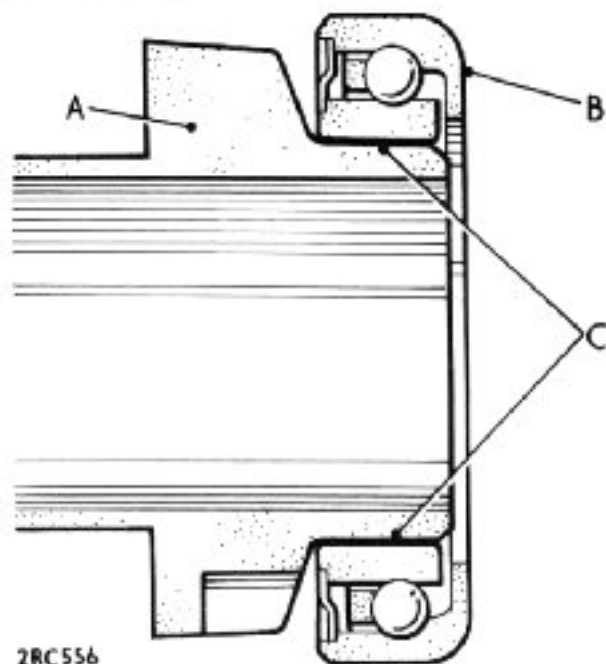
**Fig. 2 Clutch release bearing and sleeve assembly**A—'Ferrobestos' sleeve
B—Sealed bearing
C—'Loctite' bonded joint

The above modification has been introduced to reduce the possibility of the clutch release sleeve becoming seized on the front cover extension during arduous driving conditions and to improve the bearing lubrication.

The assembly comprises a sleeve manufactured from 'Ferrobestos' and a new release bearing which is packed with grease and sealed. These are bonded together by Loctite high strength retaining compound.

The assembly is interchangeable with the earlier bearing and sleeve but is only available as a complete assembly.

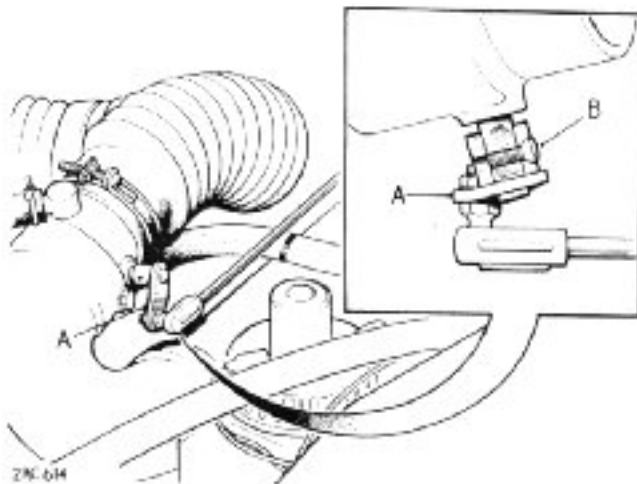
Fig. 1 Inlet manifold butterfly valve

If this condition is present on a vehicle, it can cause either a loss of vacuum or excessive smoke to be emitted from the exhaust. Should Distributor or Dealer personnel come across this problem they are advised to first check the positioning and tightness of the clamp screw. If the component is found to be loose it is recommended 'Studlock' or 'Loctite' is applied and the screw re-tightened.

Production Department, as an interim measure, from April, 1972, have been applying 'Studlock' on the screw. To overcome this possible condition permanently, however, it is anticipated that a re-design of the particular area concerned will be carried out.

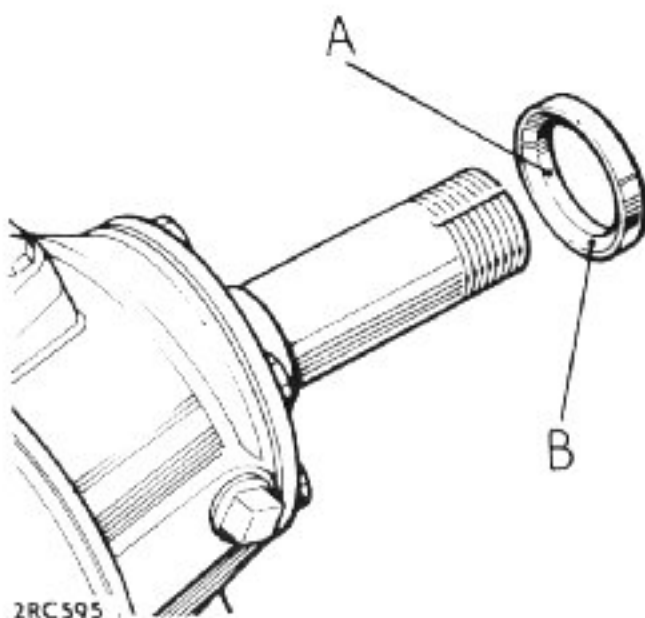
Fig. 2 Distance piece for inner hub bearing

MODIFICATION: Introduction of mild steel distance piece to eliminate oil leaks arising from previous sintered iron type.

NOTE: Because of the material change the mild steel distance piece cannot be removed in the same way as the sintered iron type.

In this case, it is recommended that, by exercising reasonable care the distance piece can be partially cut through with a sharp chisel to loosen it, when it can be gently prised off.
