SERVICE INFORMATION

Vol. 1 No. 1

LAND-ROVER PETROL AND DIESEL MODELS

The Rover Company Limited, Solihull,
Warwickshire, England

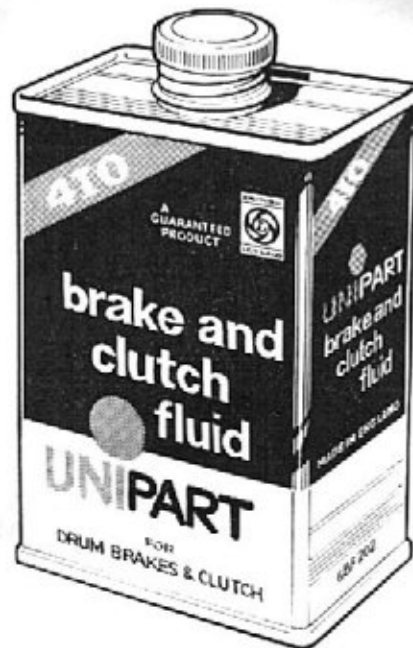
2RC 127

NOTE 2: Earlier stocks of Unipart 410 may be either colourless or yellow. All future supplies will be Crimson.

CAUTION: Re-seal tins, especially larger ones, immediately after use. Unsealed fluids will absorb moisture resulting in subsequent loss of braking efficiency.

Fig. 1 'Unipart' 410 brake and clutch fluid

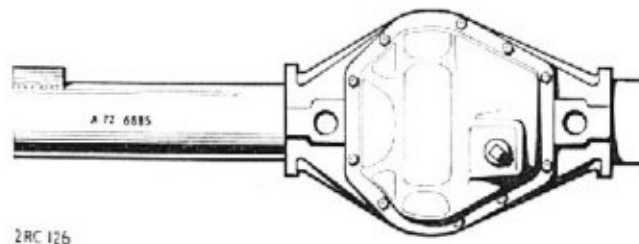
REMARKS: In Land-Rover Service News Letter, Vol. 3, No. 21a, the commencing number of the Salisbury manufactured rear axle was given as 91100001A. This is incorrect, the axles are actually numbered in the range commencing H71/43 onwards.
Distributors and Dealers are requested to amend their records accordingly.

Fig. 2. Location of 'Salisbury' rear axle number

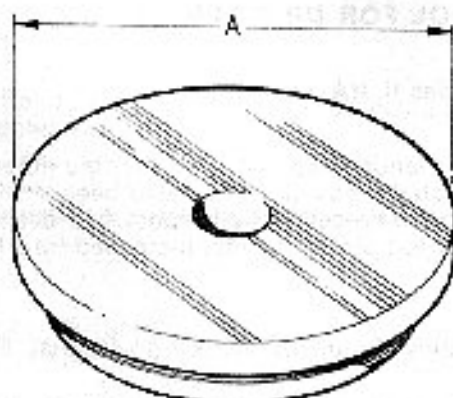
2RC 337

In conjunction with the above modification, the opportunity has been taken to provide a new press block which gives a greater contact area with the pinion bearing cup. The new press block Part No. 262757-1 replaces the earlier press block Part No. 262758 for the following models:

Fig. 3 Press block for pinion head bearing

Land Rover Series IIA with axle serial numbers from Suffix 'B' onwards, and all Land Rover Series III models.

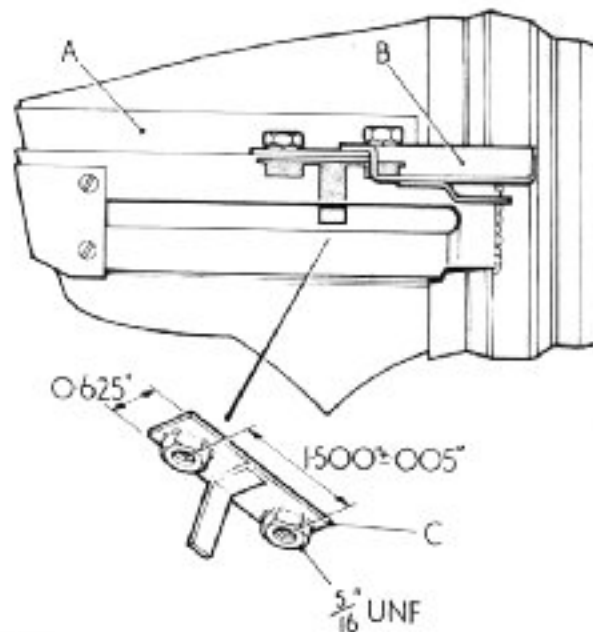
2RC568

NOTE: Since difficulty has been experienced in locating and retaining the nuts in the intermediate member while tightening the bracket fixing screws, a nut plate assembly Part No. 347511 will eventually be supplied for this conversion in place of the four plain washers and nuts specified above.

Fig. 3 Pivot bracket conversion

In the meantime it is recommended that a nut plate is manufactured to facilitate assembly.

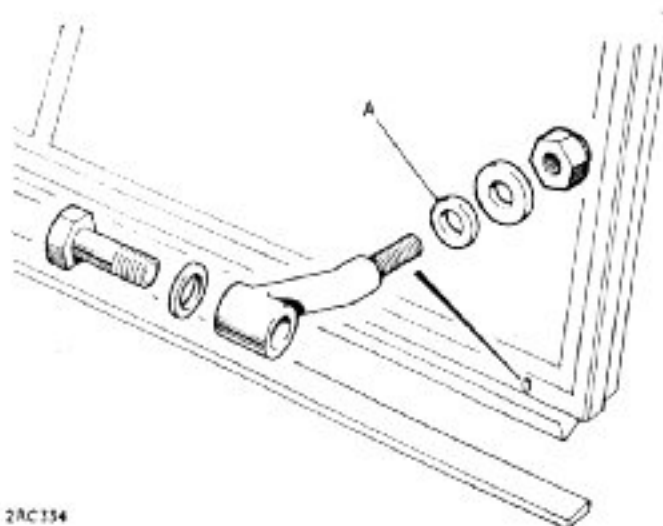
2AC154

Item 42**SUBJECT: WINDSCREEN PIVOT ARM****MODEL:** Land-Rover Series III.**MODIFICATION:** Change of washer material.**PCMI TRANSPARENCY:** The information detailed in this item has already been included in the current transparency.**LITERATURE AFFECTED:** Land-Rover Series III Parts Catalogue Supplement, Bonneted Control models, Part No. 608049, page 16.76.**PART NUMBER:** Copper washer for windscreen pivot 2 232038**REMARKS:** In certain instances the fibre washer between the windscreen and the pivot arm cracks after initial tightening and during service this washer is displaced by vibration, thereby allowing movement between the windscreen assembly and the windscreen pivot arm. The eventual consequences of this condition is a cracked or broken windscreen pivot arm. The fibre washer has now been replaced by a copper washer and this should be used for all replacements.

Fig. 3 Windscreen pivot arm fixings

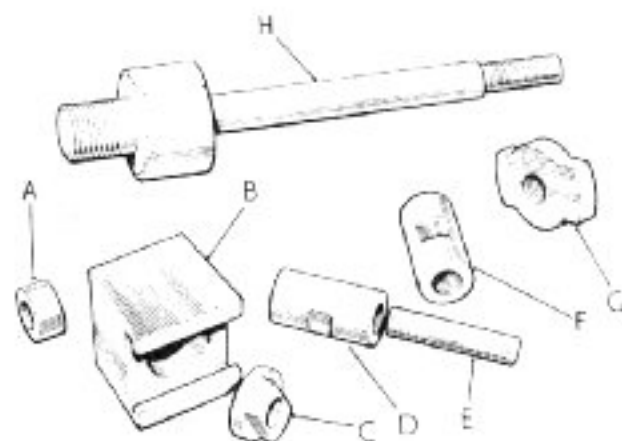
2RC 541

REMARKS: When stocks of the earlier impulse tool and adaptor kit 530101 are exhausted only the above listed tool kit 530101A will be stocked. The kit is for use with the current impulse tool 18G284 which, if not held, must be ordered separately.

Fig. 1 Impulse tool kit 530101A

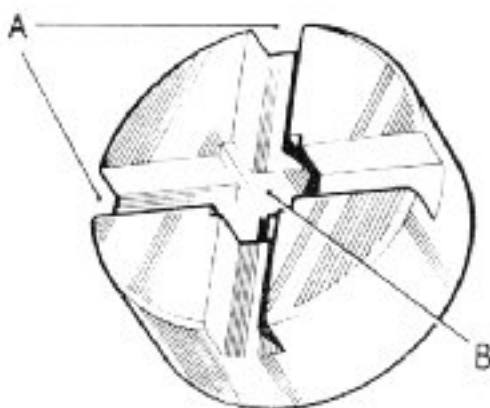
2RC 322

Item 47**SUBJECT: SERVICE TOOL FOR GEARBOX MAINSHAFT NUT****MODELS:** All Land-Rover.**MODIFICATION:** Introduction of a torque spanner adaptor for use with the existing box spanner, Part No. 600300, for the gearbox mainshaft nut.**LITERATURE AFFECTED:** Land-Rover Series II and IIA Workshop Manual, English, Part No. 606407, Operation C1-22.
Land-Rover Series III Repair Operation Manual, English, Part No. 607314, Operation 37.20.25.**PART NUMBER:** Torque spanner adaptor for mainshaft nut spanner 1 RO 1013**REMARKS:** The current gearbox build specification requires the special nut Part No. 217477 at the transfer gear end of the gearbox mainshaft to be tightened to 12,5 kgf.m (90 lbf.ft.) prior to turning up the lockwasher. The above listed adaptor is now available for this purpose and is designed to fit on the end of the existing mainshaft nut spanner Part No. 600300. It is recommended that this torque loading be applied on earlier, as well as later, gearboxes during the applicable overhaul procedure.

Fig. 2 Torque spanner adaptor RO 1013 for mainshaft nut spanner
